Re: January 2015 Monthly Progress Report

Gasco Sediments Site within the Portland Harbor Superfund Site

Attachment A Monthly Visual Monitoring Report for Pilot Cap Vicinity

# **Visual Observations Log Form**

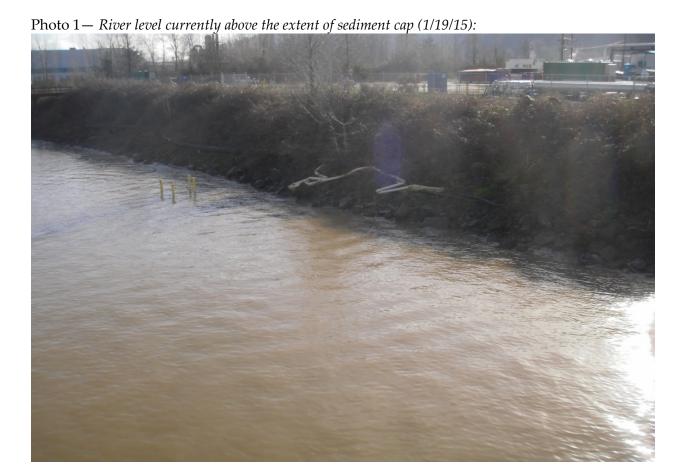
No erosion/deposition is evident along the shoreline. The shoreward extent of the cap was not visible due to high river water elevation and the extents of the organoclay mat material were also submerged. (Photo 1).

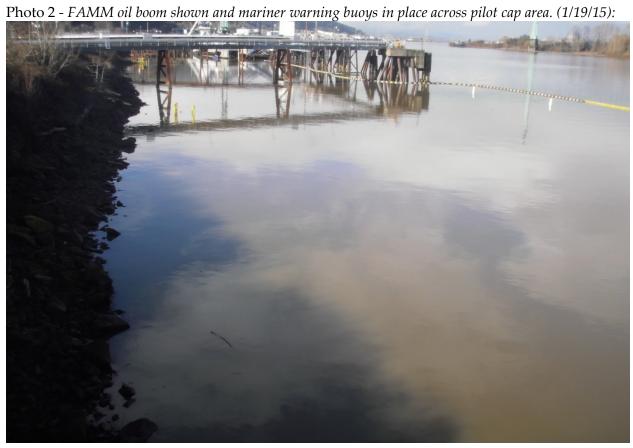
Observations of Long-term Controls (i.e., oil booms, organo-clay mat, etc.) During the observation, the Fuel and Marine Marketing (FAMM) containment boom was placed across the cap area, between the upriver corner of the ship dock and the wooden dolphin (near the upriver extent of the site and near the Siltronic Corporation outfall). Buoys that identify the cap area to mariners are in place as installed. The position of the FAMM oil boom, warning buoys, and a general overview of the site shoreline is shown in Photo 2.

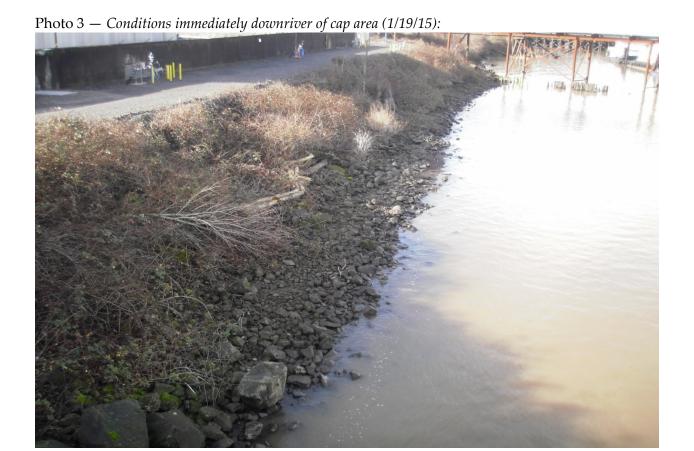
No sheen is evident in or around the cap area. Photo 3 shows the water surface and shoreline immediately downriver of the sediment cap.
